Power Generation

TURBINE BLADE ADJUSTMENT FOR PERFORMANCE RECOVERY

¹ PT PLN Indonesia Power

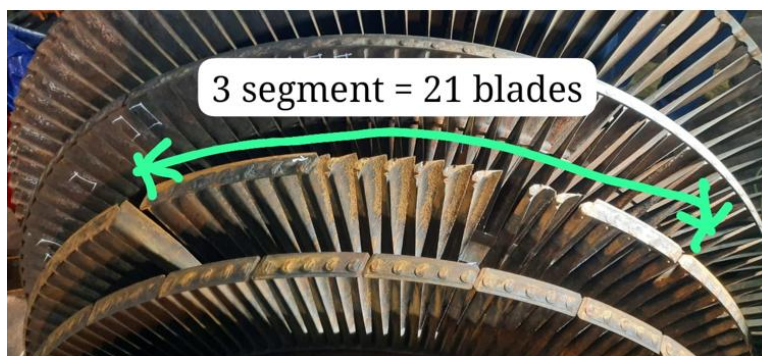
Balancing trial was then conducted by adding trial weights at hole numbers 9 and 11 on plane 2 (generator side). However, calculations indicated that a balance weight of 1262 grams was required to counteract the unbalance an unusually large amount for Dieng Geothermal Power Plant Unit 1's turbine. With a mass weight like that, it is not possible to continue the balancing process. Therefore, a deeper investigation was undertaken by opening the upper casing to determine the root cause of the issue. Upon inspection, a broken turbine blade was discovered on stage #5, generator side, resulting in significant mass loss and rotor unbalance (as shown in Figure 1).

Figure 1. Broken Blade Finding

Corrective Action Plan for Turbine Repair and Unit Reoperation According to standard procedures, reblading is required. However, no spare blades were available at Dieng Geothermal Power Plant. According to OEM standards, reblading must be performed. However, ordering new OEM blades would take approximately eight months (exclude delivery time), during which the unit would be inoperable. An option to remove the stage #5 turbine blades was considered. However, this carried the risk of damaging the blade platform's "Christmas tree" structure, potentially preventing future blade installation. The final decision was to cut the stage #5 turbine blades for short-term recovery, it was decided to proceed with cutting the stage #5 blades, accepting the risk of reduced efficiency or output derating with the aim of accelerating the recovery to resume operation while awaiting the delivery of new blades. The Problems is how to establish a proper procedure for turbine blade cutting and the impact of blade cutting on vibration and operating pattern.

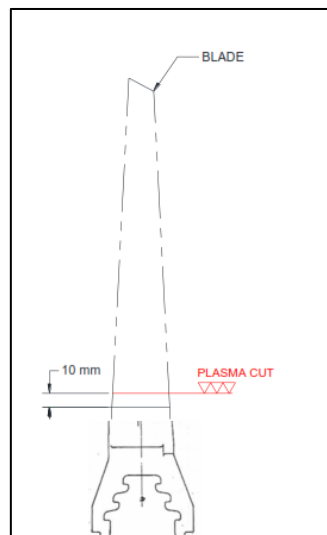
Figure 3. Finishing Cutting Blade Diameter

According to Figure 3, Cutting of Stage #5 Turbine Blades Using Plasma Cutting Method. Perform blade cutting operations in accordance with the standard procedure outlined in API RP 687, cut the blades precisely at the designated location above the platform to ensure removal from the steam path without damaging the blade housing or platform structure. Conduct post-cutting inspection to verify clean cuts and absence of collateral damage

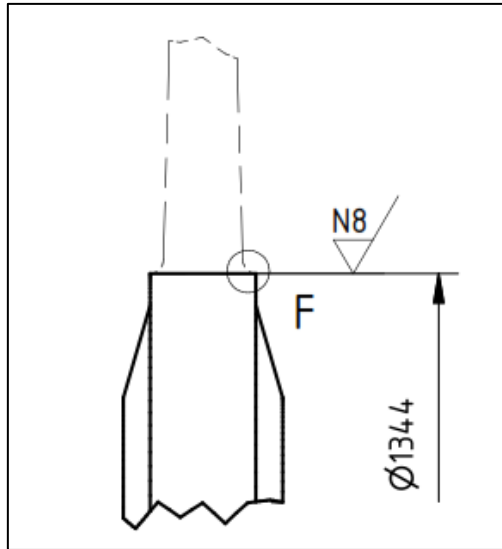
Figure 4. Final Diameter and Roughness

The drawing of Figure 4 smoothing using hand grinding and adjusting the final diameter and et the surface roughness and performing final machining using a lathe machine.

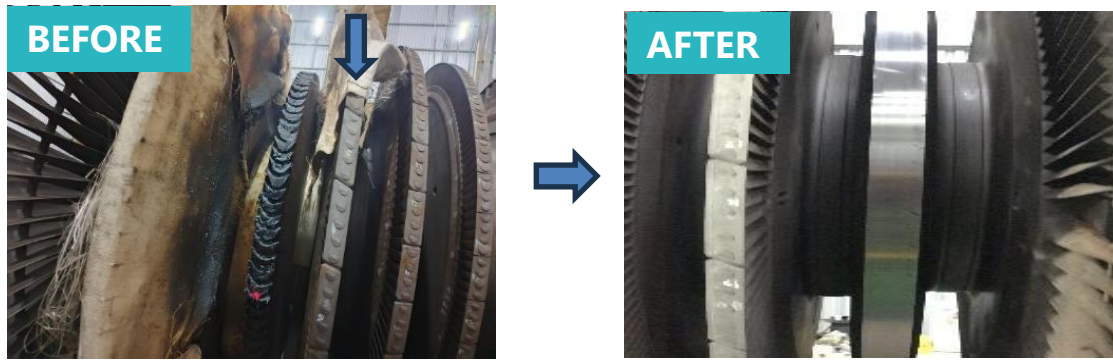
The final surface condition (as shown in figure 5) of the turbine blade cutting at Power Plant meets the standard roughness values associated with flame cutting, sawing, and chipping processes, which typically fall within the range of 6.3 – 100 μm (Roughness Grade Number N9). However, post-operation inspection showed that the achieved surface roughness improved to one level higher, equivalent to Roughness Grade Number N8, indicating a smoother finish than initially expected. Figure 6 shown the result from cutting blade using plasma cutting method.

Figure 6. Result of the Blade Cutting Process

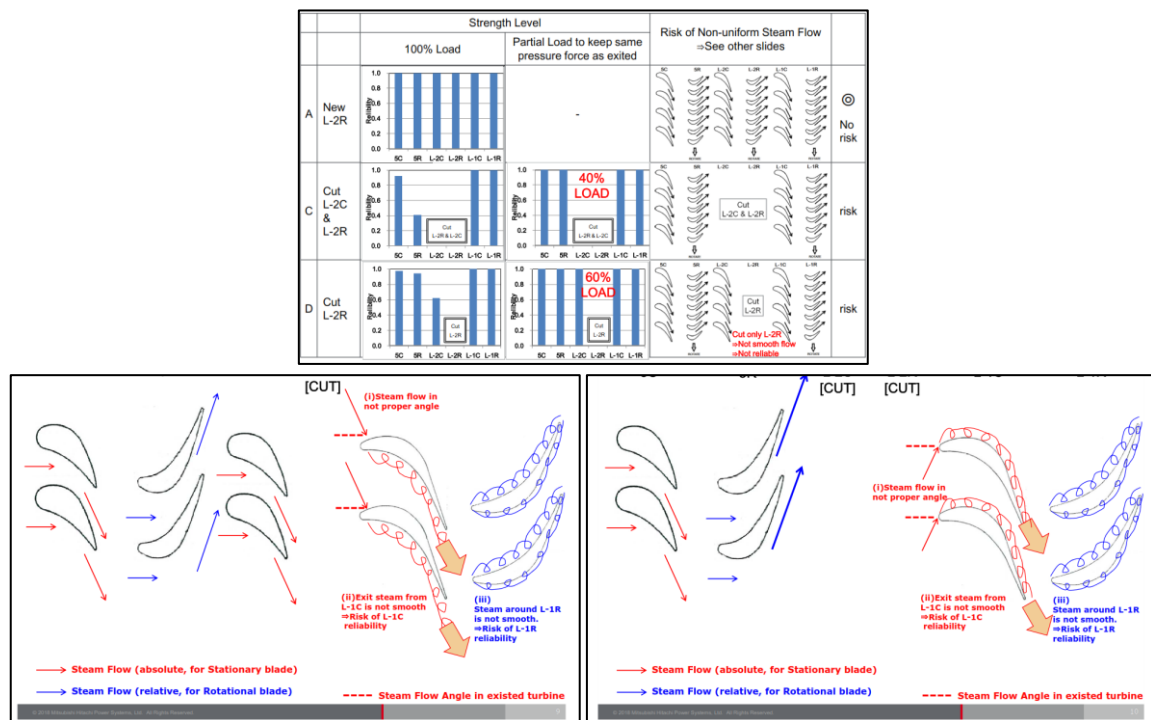
Figure 7. Turbine Steam Flow Characteristics

The referenced diagram on Figure 7 illustrates the steam flow characteristics and mechanical configuration when a blade stage is removed. It indicates that, in such cases, the diaphragms can remain in place to help maintain flow direction and minimize disruption to downstream stages, provided that no damage or obstruction exists. This solution aims to preserve turbine efficiency while mitigating mechanical imbalance risks after stage removal.
