Power Generation

TURBINE BLADE ADJUSTMENT FOR PERFORMANCE RECOVERY

¹ PT PLN Indonesia Power

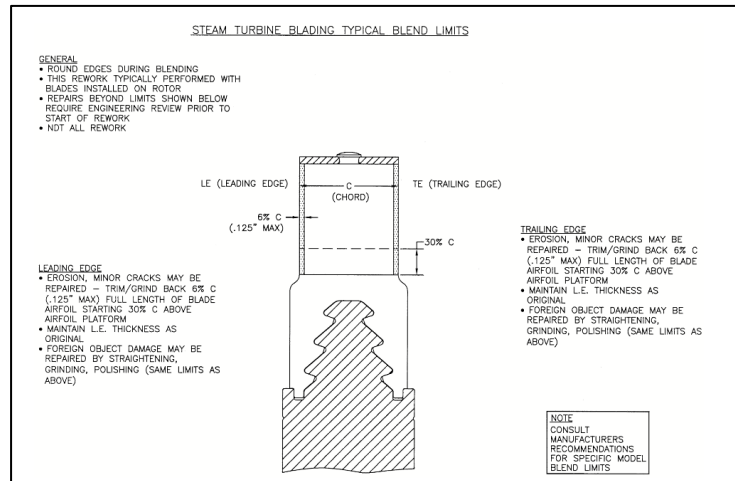
Figure 2. Blade Rotor Typical

The turbine blade removal and cutting process at Power Plant was conducted during the vibration recovery program from March 1 to April 15, 2025. This work was conducted following the API Recommended Practice 687 – Rotor Repair Guidelines. The The blades were cut along the platform section that connects to the blade housing. According to Figure 2 from API RP 687, the airfoil begins approximately 30% above the platform. To ensure the blade no longer functions within the steam flow path, the cutting was executed at that location
